**Department of the Marine and  
Natural Resources**

**Killybegs FHC  
Refurbishment of Piles in Landing Pier  
and Blackrock Pier**

**Post Maintenance Inspection**

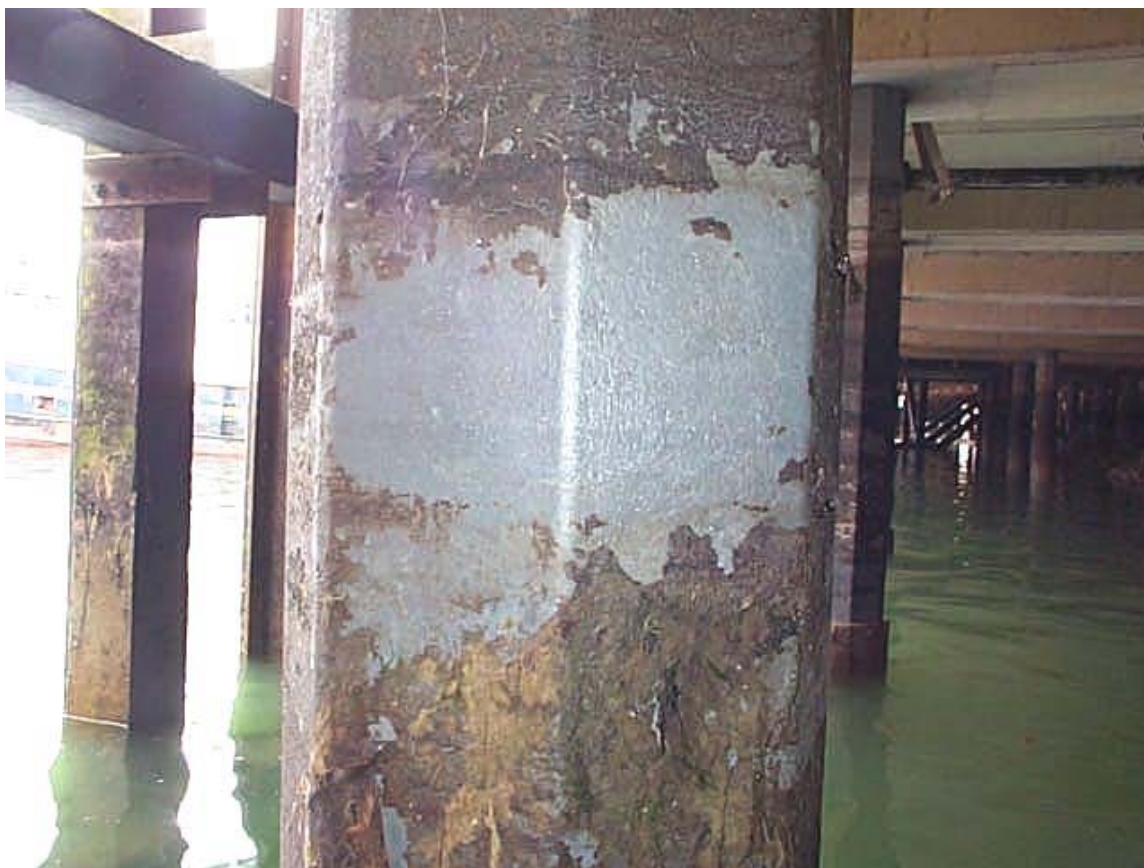
When the DFT readings taken during the inspection of the Zinga coating, see appendix A, are compared to those take at completion of the works no significant change can be seen.

*Plate 1. Area of pile cleaned for inspection*

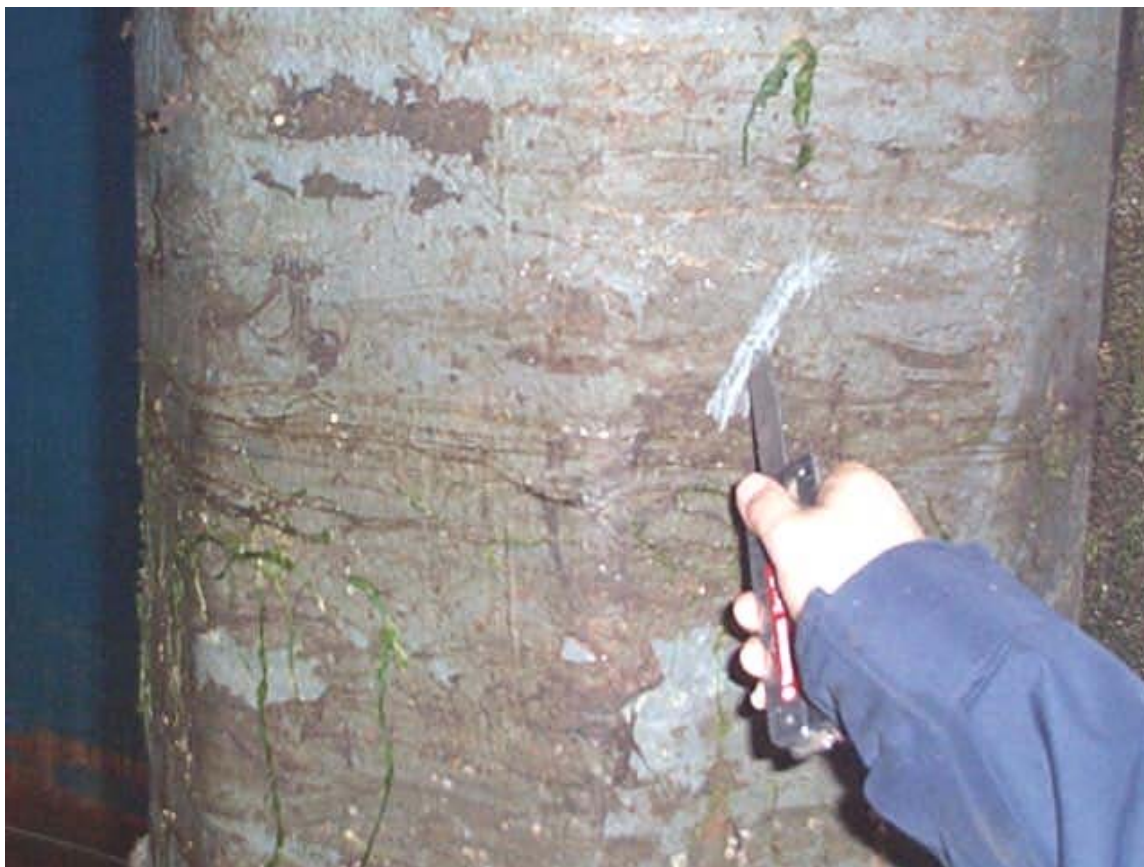
The general condition of the Zinga coating was found to be good with only small amounts of rusting found in areas where very limited access had prevented proper preparation and

application, i.e. to the bottom of the piles to row A, that are surrounded in rocks and the tops of the piles to row Z which are surrounded in steel work. The hardness of the coating was found to be good and when a small area of the coating was removed, bright shiny metal was

revealed. No cracking or disbondment was found. The joint between the top of the pile and the deck concrete showed no signs of under cutting.

*Plate 2. Testing for hardness and bounding of the coating to steel.*

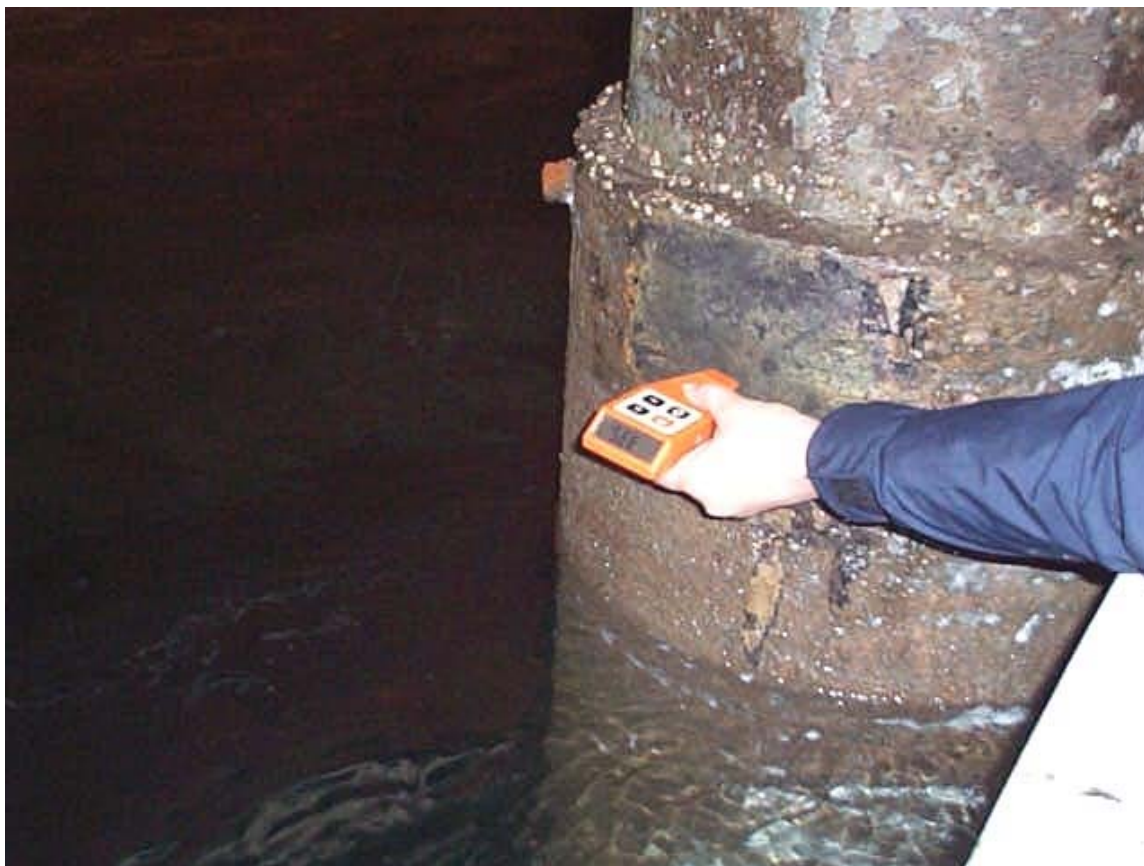
We can not compare the coating thickness readings taken during the inspection with those taken at completion of the works, as they were not taken from the same points. The readings taken indicate that there has been no noticeable depletion of the galvanised coating to the collars, with readings remaining at 300 microns or above.

*Plate 3. Thickness Readings of Galvanising to Collars*

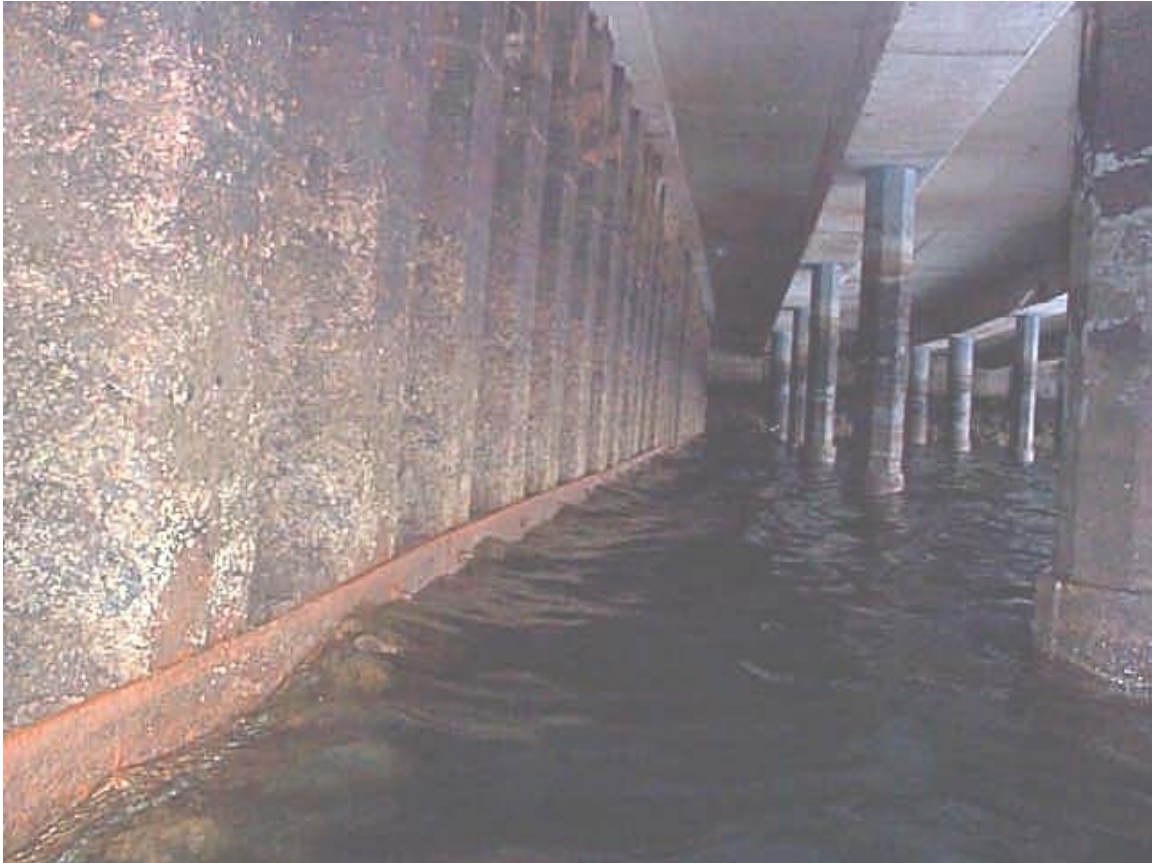
All steel plates fitted were found to be in place and no fixing bolts were missing. Light corrosion was noted on all plates.

*Plate 4. Steel plates to Wave Curtain.*

Following the final inspection of the works the only recommendation to be made would be the fitting of anodes to the steel plates used to repair the wave curtain.
