# Quartes Cattle Feed Company - Belgium

In 1980 ZINGA was used for the recharging of old hot-dip galvanised silo's for livestock-feed concentrates and premixes (4 silos, 20 m in height, 4 m in diameter, approx. 4000 m<sup>2</sup>) at the cattle feed company Quartes (formerly named Versele-Laga). The work was executed by employees of the company with brush and roll.

Type of intervention	<b>SURVEY REPORT</b>
Object	4 silo's for grain / flour storage
Location	Quartes (ex Versele-Lagae nv) at Deinze
Date inspection	13/05/03
Time inspection	14:30

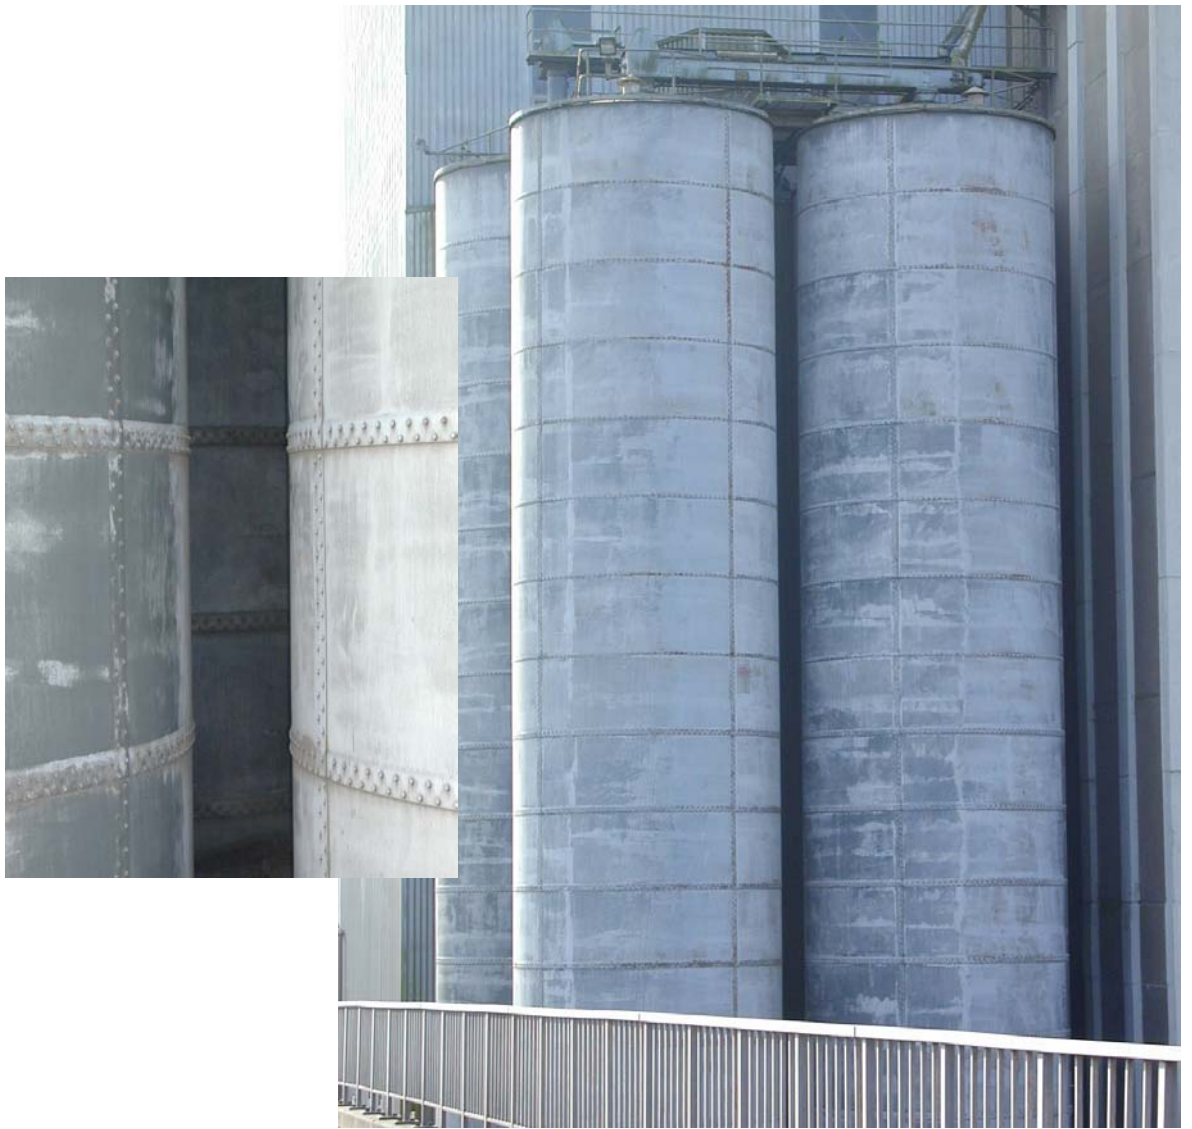
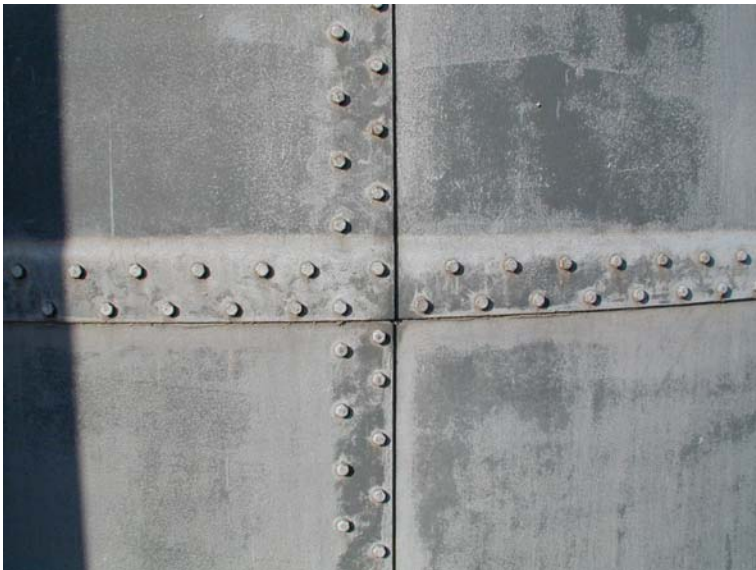
These pictures were taken in 1997.

These pictures were taken during an inspection in 2001, more than 20 years after the application.

The silos were still in perfect condition and there was no need for maintenance.
