National Cheng Kung University
Materials Corrosion Prevention Center
Daxue Road 1, Tainan
Tel. : (06)2757575-62942

Material Erosion, Writing nr. MCPC 88037

TEST REPORT SUMMARISED TRANSLATION
--

Name of the test : 1000 hours salt spray test

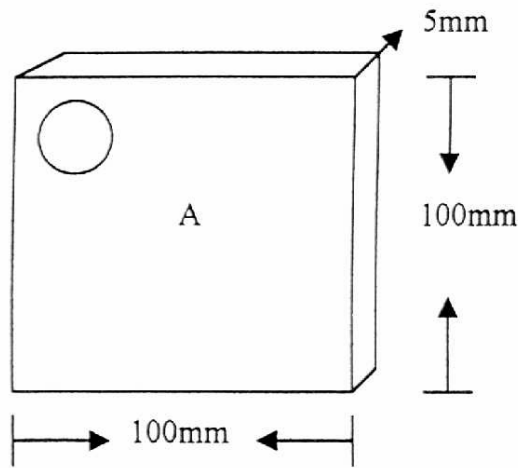
Picture 1 The measurements of the test plates
 A : The sample surface that has to be examined and evaluated

(1) Size of the test plates :

a square of 100 mm x 100 mm x 5 mm. (See picture 1.)

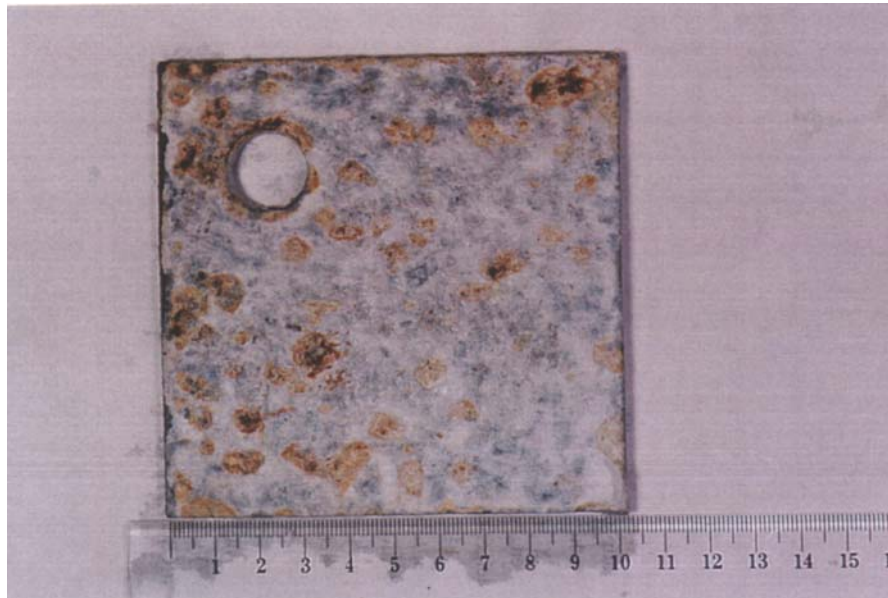
Picture 2 The surface appearance of the sample with serial number 2 after the 1000 hours salt spray test.

- (1) The salt spray test had a total duration of 1000 hours.
- (2) When the salt spray test had reached 100, 172, 275, 365, 659, 666, 778, 857, 967 and 1000 hours, the surface appearance of each sample was examined and the results were noted in table 2.
- (3) Picture 2 is a picture of the surface appearance of the sample with serial number 2 (a hot-dip galvanised plate without topcoat) after the 1000 hours

salt spray test. On the surface of the sample you can clearly distinguish the formation of red rust.

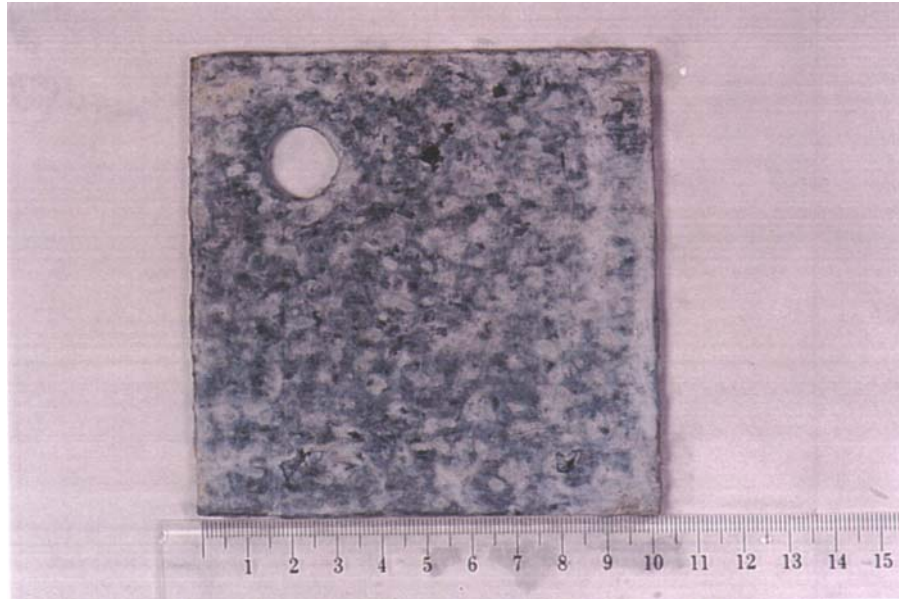
Picture 3 The surface appearance of the sample with serial number 4 after the 1000 hours salt spray test.

- (4) Picture 3 is a picture of the surface appearance of the sample with serial number 4 (a hot-dip galvanised plate with 60 µm topcoat) after the 1000 hours salt spray test. There is no red rust on the surface of the sample, but there is white rust and appearance of bubbles.
- (5) Picture 4 is a picture of the surface appearance of the sample with serial number 8 (a carbon steel plate with 90 µm topcoat) after the 1000 hours salt spray test. On the surface of the sample there is no red rust and no formation of bubbles, but there is formation of white rust.

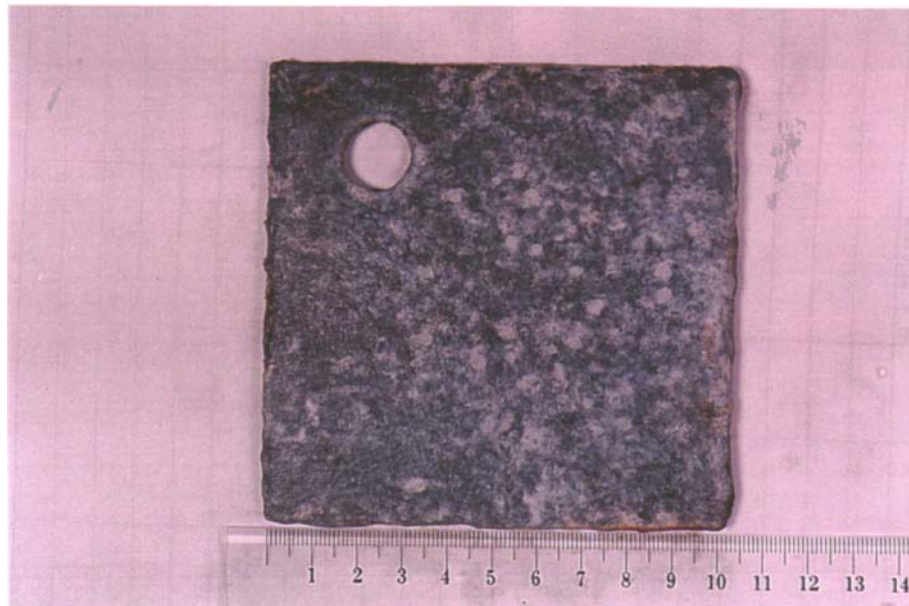
Picture 4 The surface appearance of the sample with serial number 8 after the 1000 hours salt spray test.
