Central Blasting & Painting

Zinga Trial

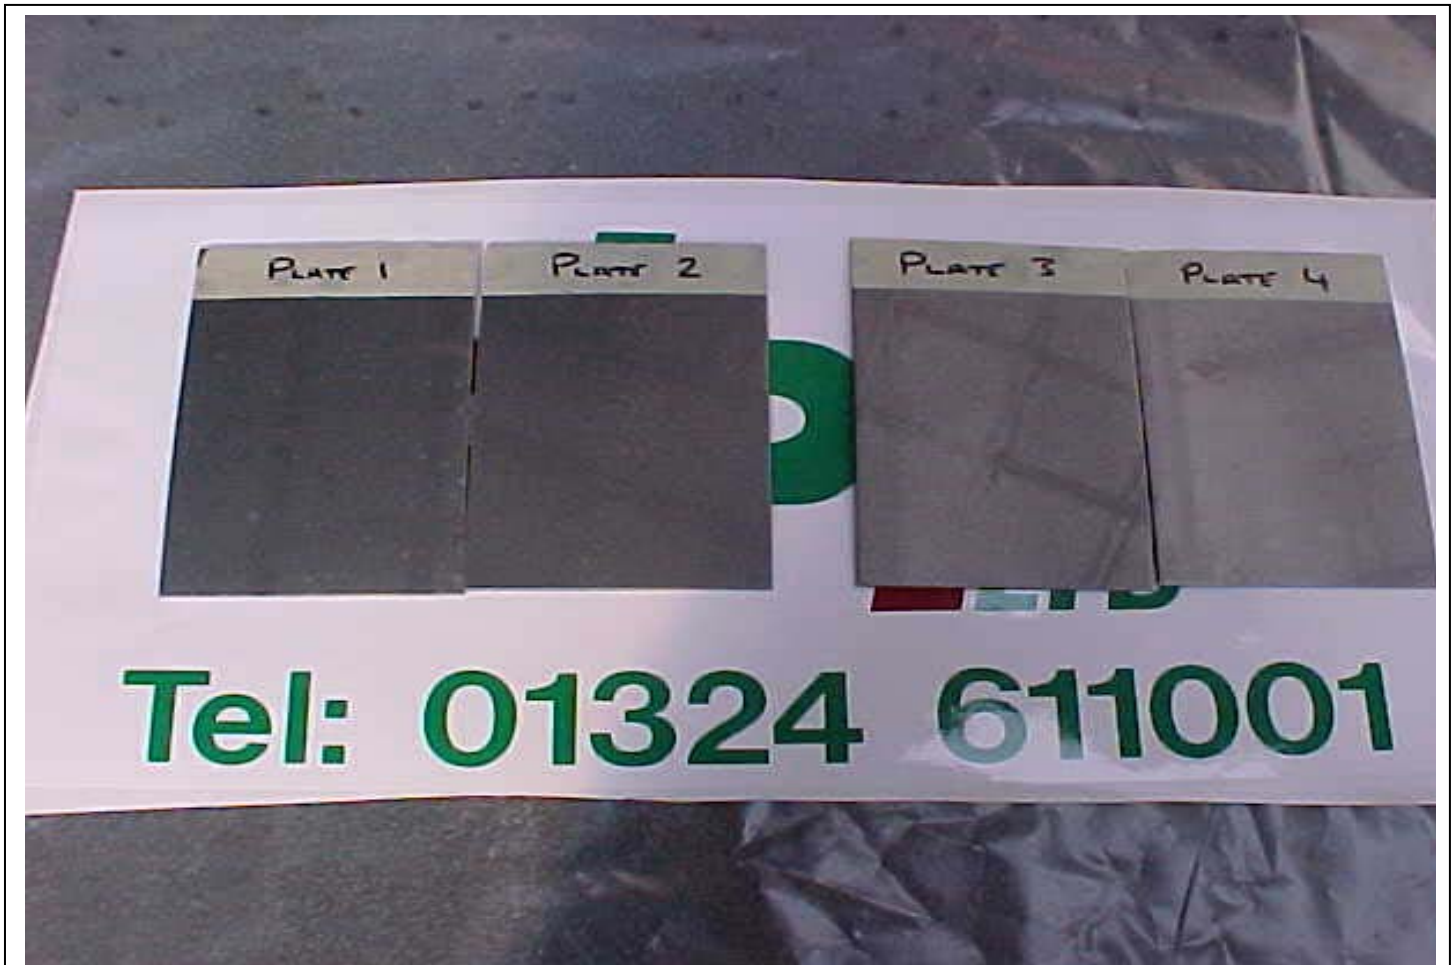
Test Plates Blasted on 26/04/02 at 11am: Blast Profile:

Plate 1:	65
Plate 2:	67
Plate 3:	69
Plate 4:	67

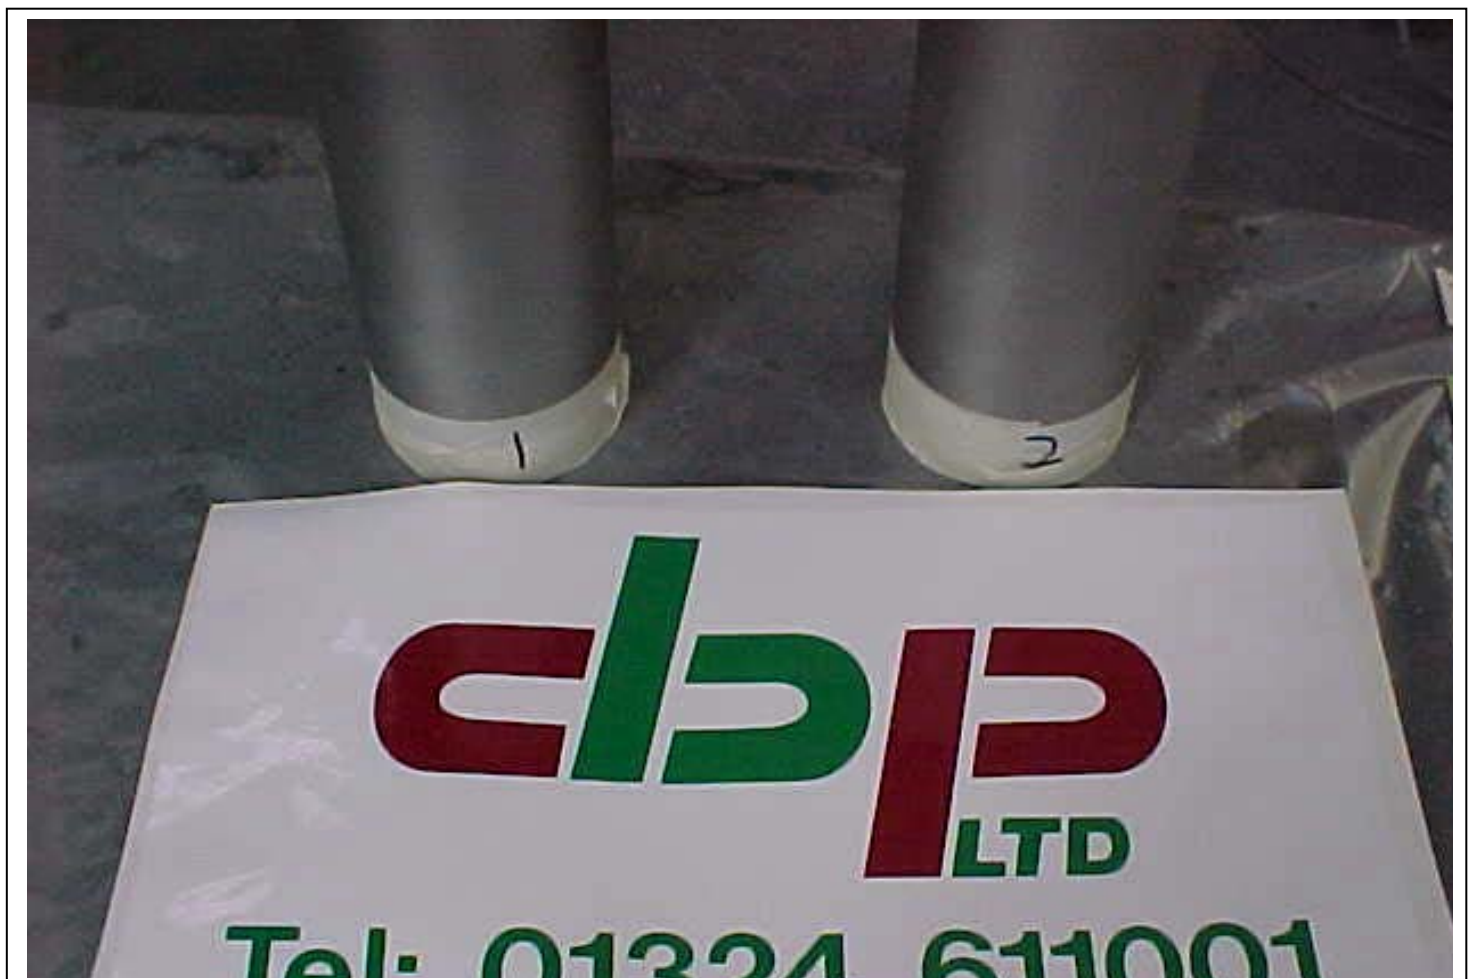
Pipes Blasted on 26/04/02 at 11am: Blast Profile:

Pipe 1;	69
Pipe 2;	67

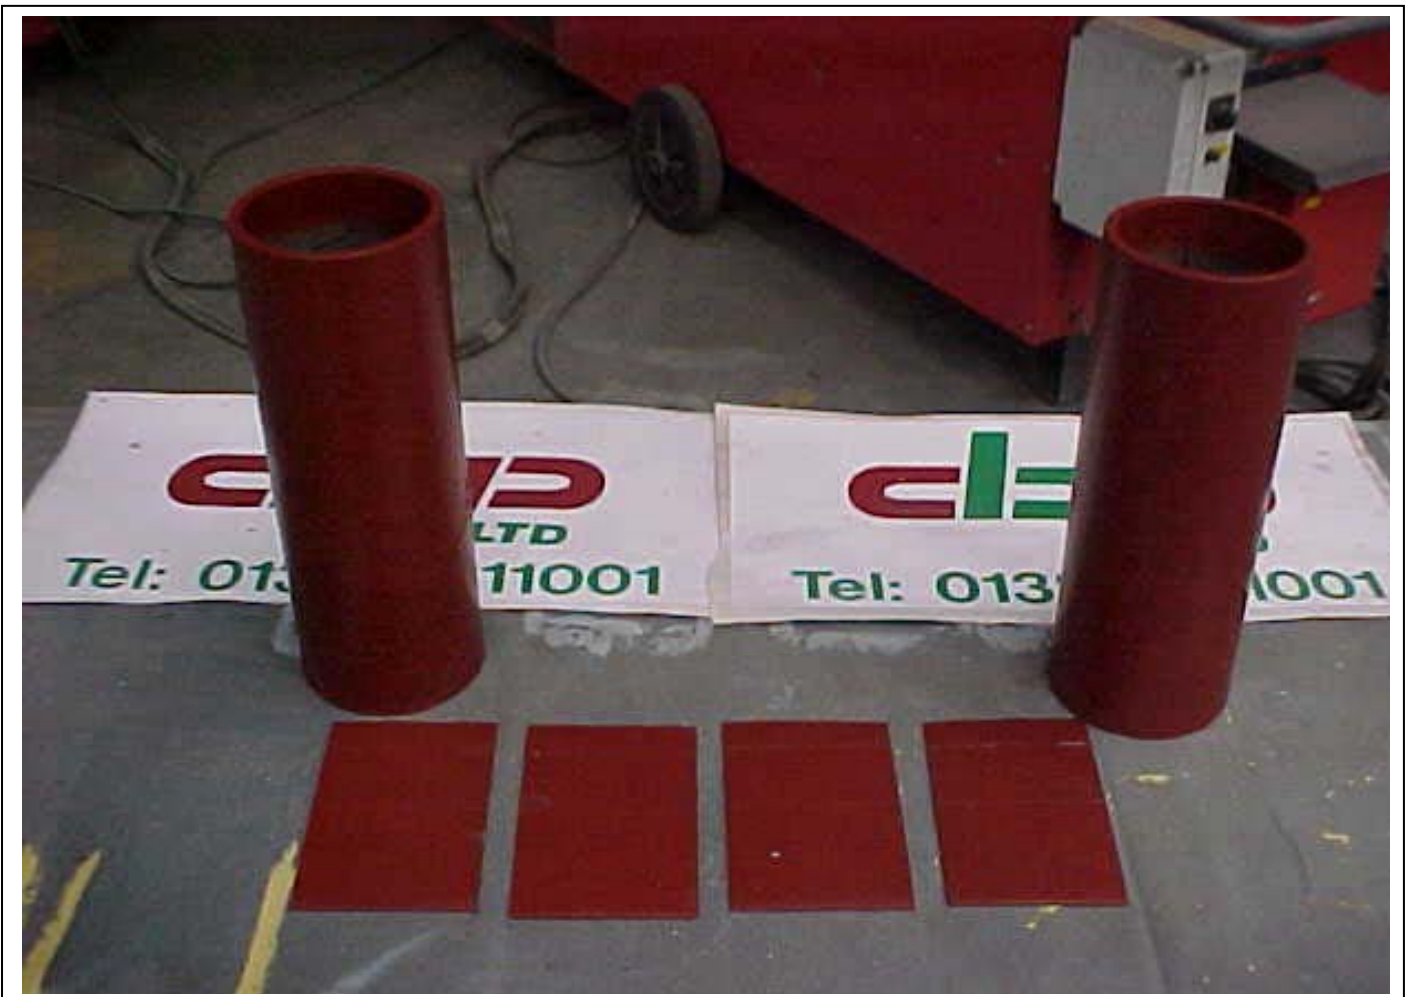
Pipes & Plates Interzone 1000 Applied 02/05/02 at 11am

Final D.F.T.'S

AVG 486

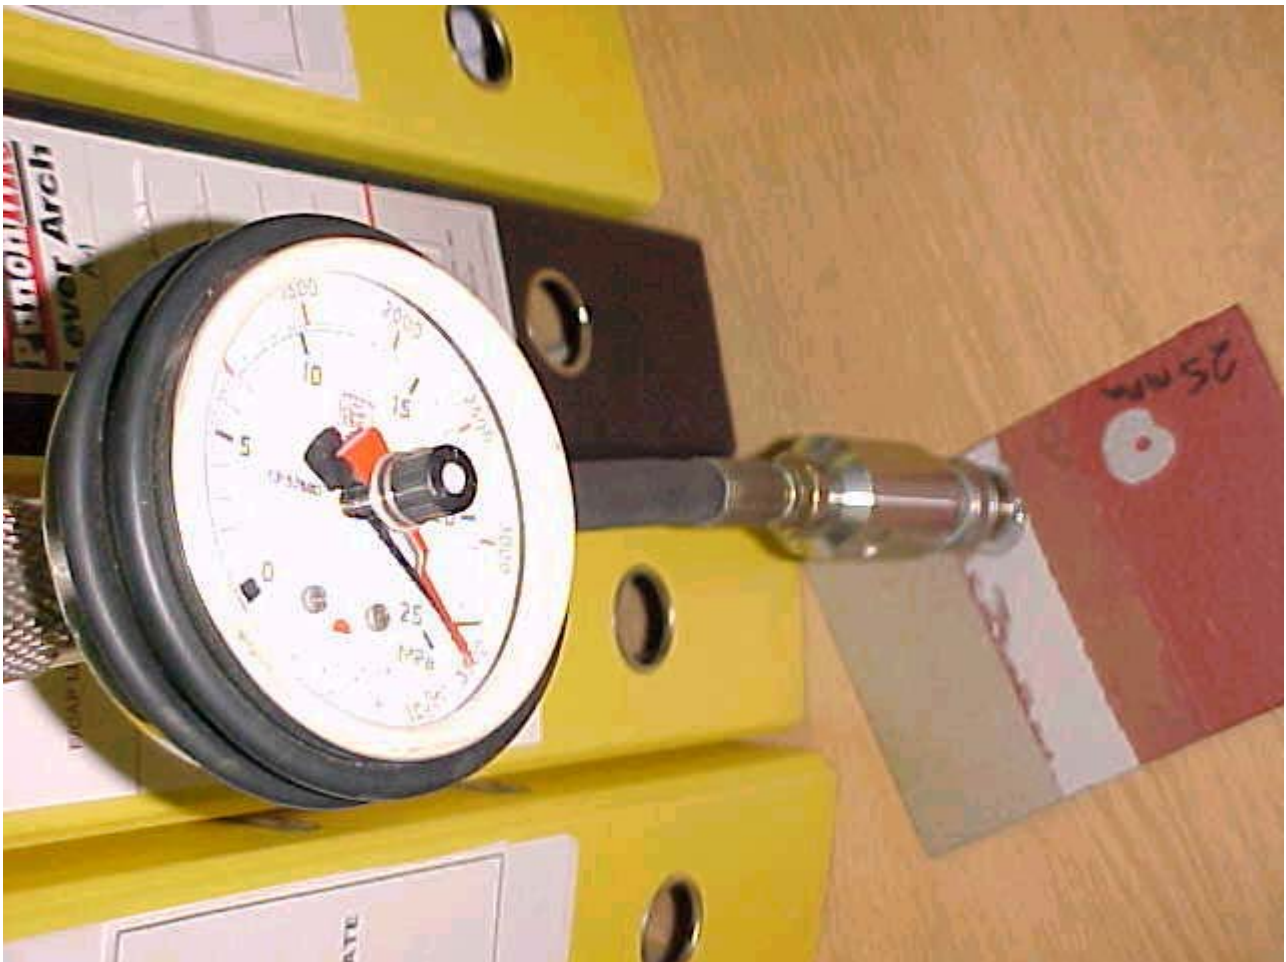
Zinga Pull off Test: 25 MPA / 3500 lbs/in² Gauge at maximum pressure did not fail.

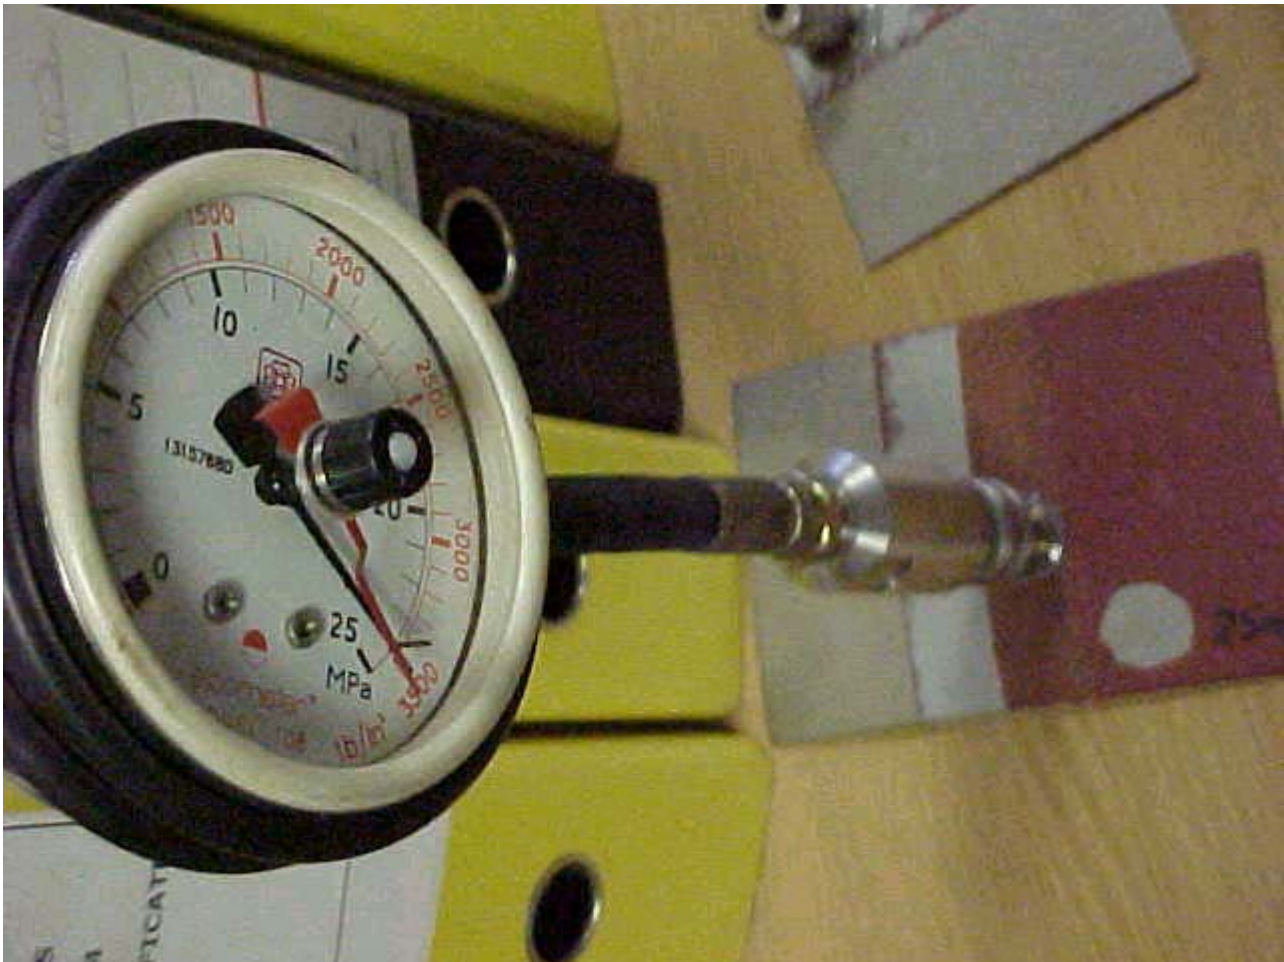
Tie Coat Intercure 269 Pull off Test: 25 MPa / 3500 lbs/in² Gauge at maximum pressure did not fail.

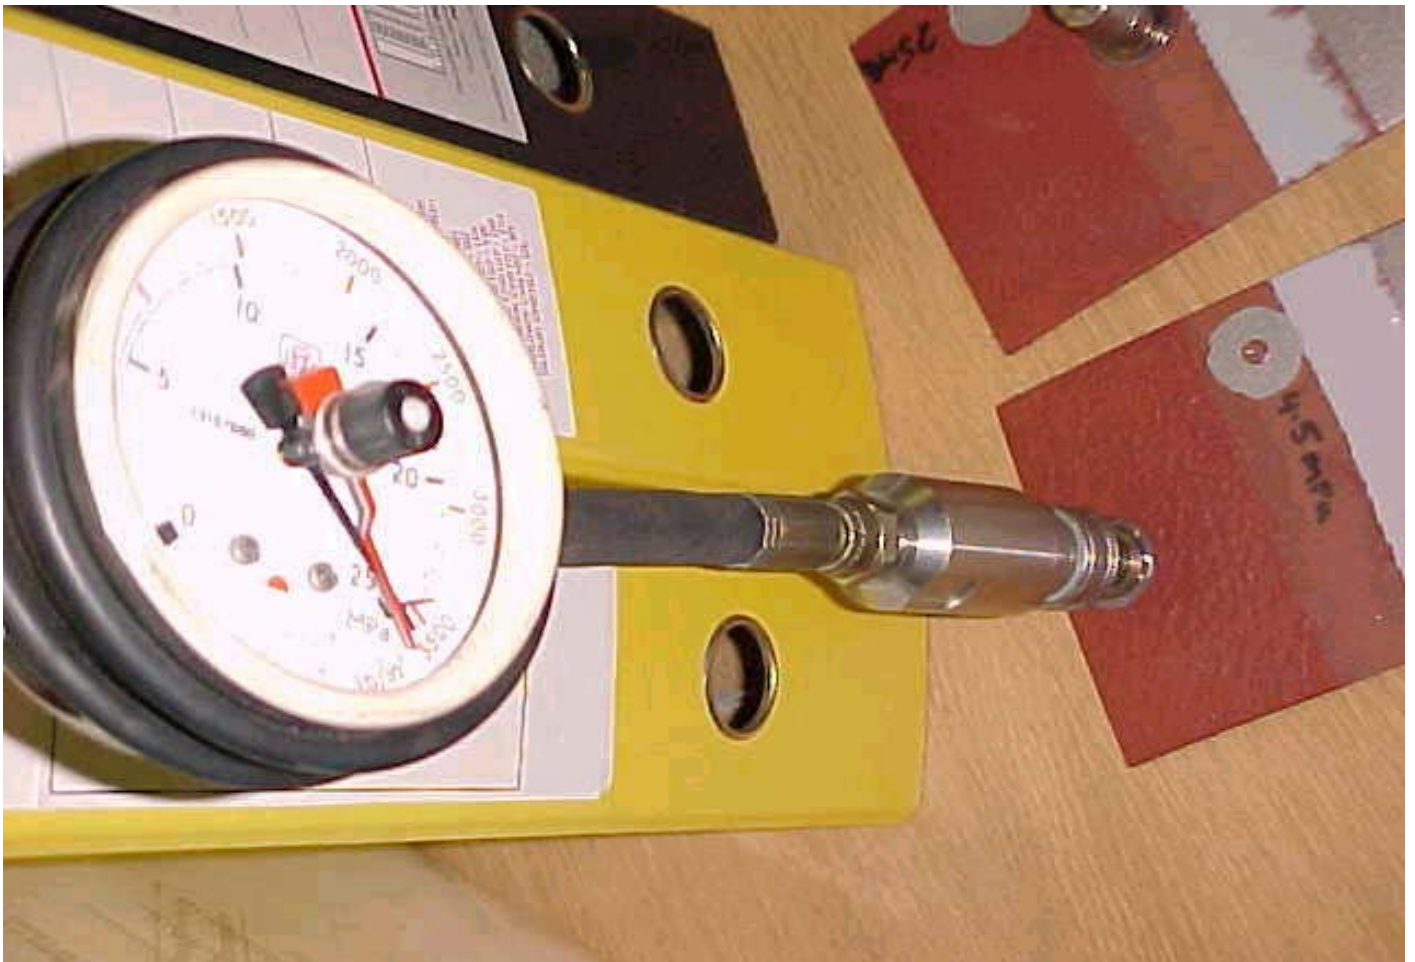
Glassflake Interzone 1000 Pull off Test: 25 MPA / 3500 lbs/in² Gauge at maximum pressure did not fail.
