CITA - Railway Wagon - Belgium

In 1993 ZINGA was applied on a wagon of the brand CITA. The ZINGA was applied as a unique system (without topcoats) for easy maintenance. The maintenance of the wagon is done by the National Belgian Railway Company (NMBS).

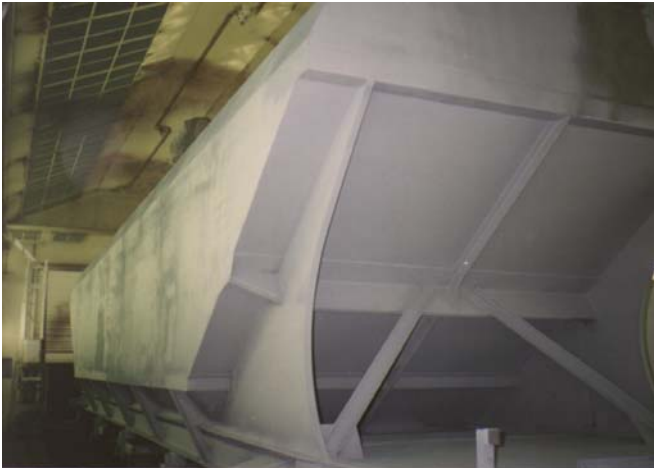
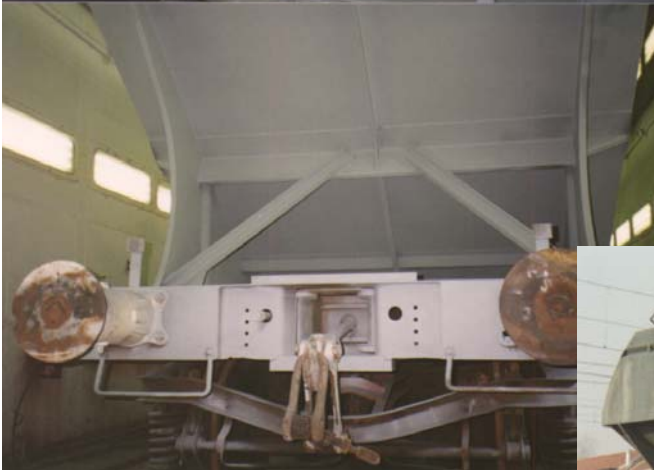
During application

System :

ZINGA 2 x 80 μ m

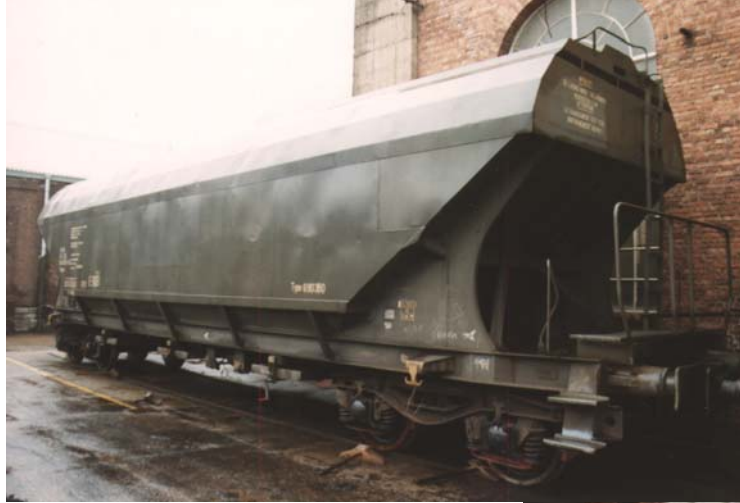
Inspection 1996

Three years after the application, in 1996, the wagon was inspected. It was still in a very good condition. There was no corrosion whatsoever.

One spot of retouch had to be done, on top of mechanical damage on the roof of the wagon.

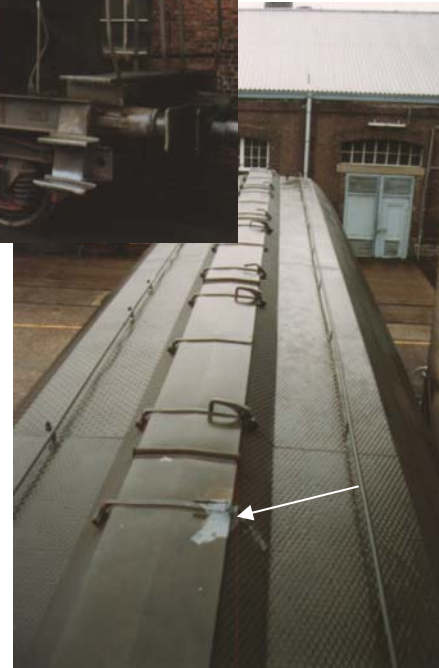
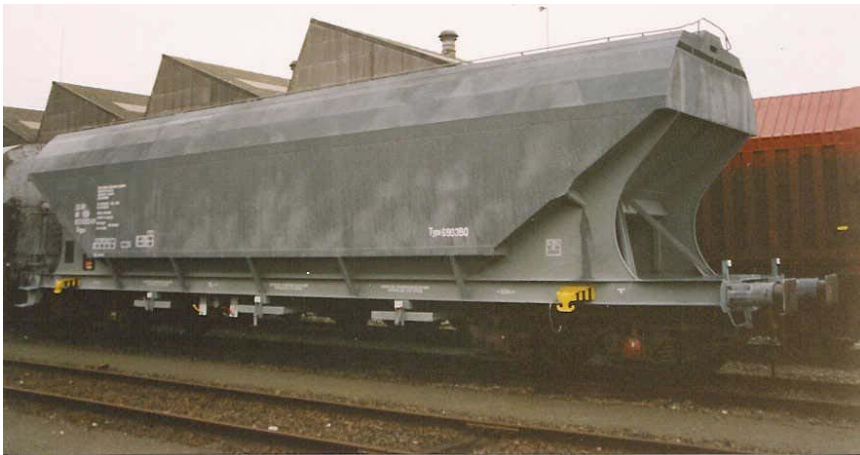
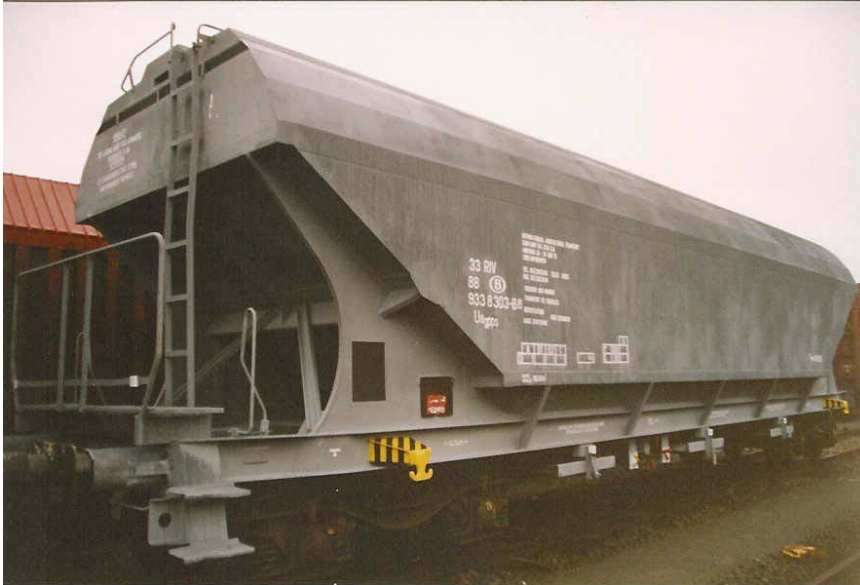
Inspection 2000

Normally for this type of wagons, maintenance is required every 6 years, in which re-blasting is essential. But even after 6 years, no maintenance and certainly no blasting was necessary for the zingaised wagon.

There was another inspection in 2000. On the pictures you see that the wagon was still in perfect condition after more than 6 years.
